Destructive testing of full-scale engineering structures as an excellent source of knowledge

Jacek SZAFRAN

Keywords: telecommunication structures, lattice towers, full-scale experiments, failure mechanism, failure mode, plastic deformations, buckling

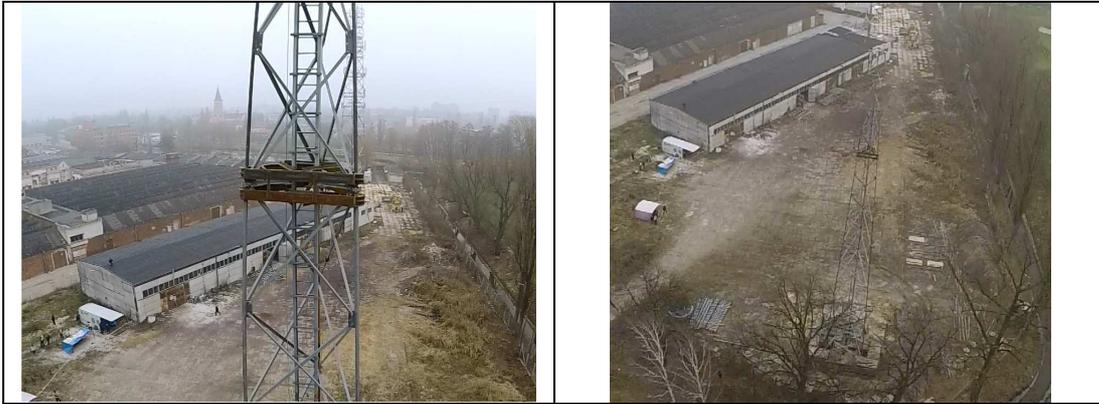
Figure 2: Top views of the experimental site

A top view of the tower during the experiment, as well as the research site, are presented in Figure 2.

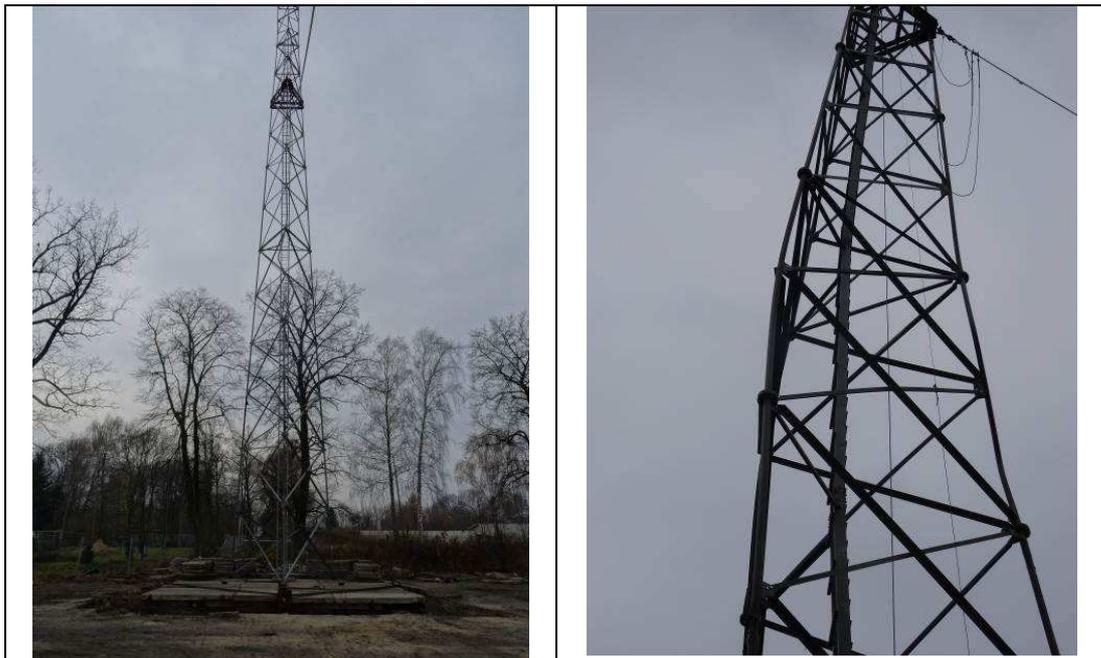
Figure 6: Failure mode of the first tested tower – view from the front (left) and the elevation (right)

Due to the fact that the towers differed at cross sections of the legs and diagonal bracing elements, buckling occurred at different heights and at different sections. Failure mode of the first tested tower is depicted in Figure 6. The attached pictures show that the main plastic deformations occurred in the

compressed leg of section S-5 in case of first tested tower. The details of the deformed legs are depicted in Figure 7.

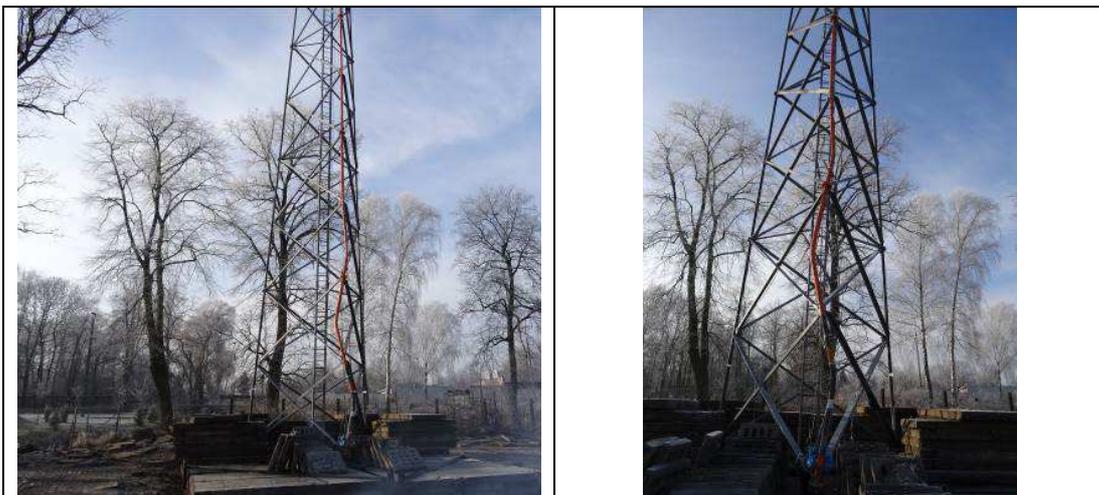
Figure 8: Buckling of tower legs in section S-7 (second test)

The buckled leg in the second tower is presented in Figure 8. It should be noticed that the joints connecting the neighboring legs remained rigid due to significant thickness of the connecting flanges, and no so-called leverage effect was present.
